CERTIFICATE OF APPROPRIATENESS

Property: 417 West 12th Street, tract 19a, 20a, and 21a, block 183, Houston Heights Subdivision. The property includes a historic 1,007 square foot residence situated on a 4,100 square foot (41' x 100') interior lot.

Proposal: Alteration – *Resubmittal* The applicant applied for a COA to construct a two story 1,498 square foot addition on top of and to the rear of a one story 1,007 square foot Contributing residence on at the November 2014 HAHC meeting. The HAHC accepted staff's recommendation to deny the item for not meeting criteria 1, 4, 8, and 9. The applicant has proposed the following revisions:

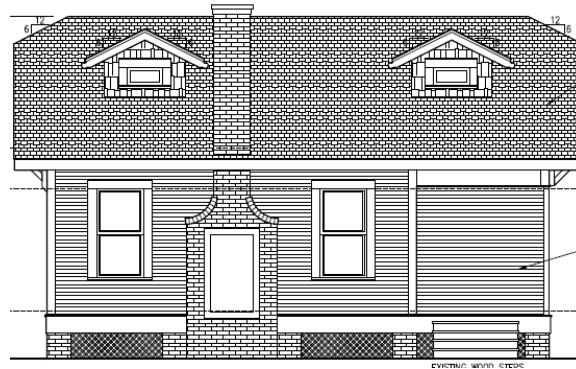
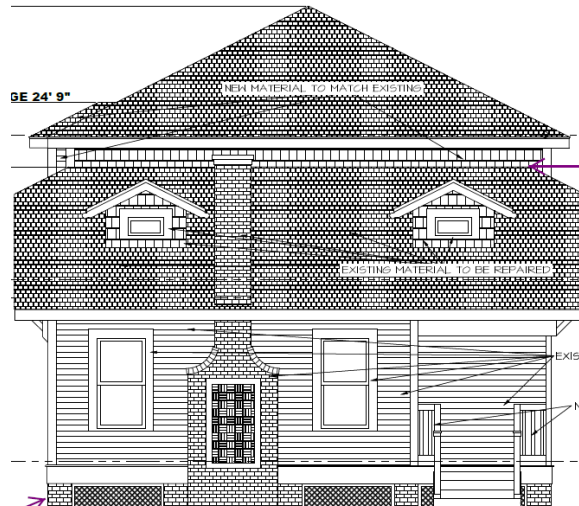
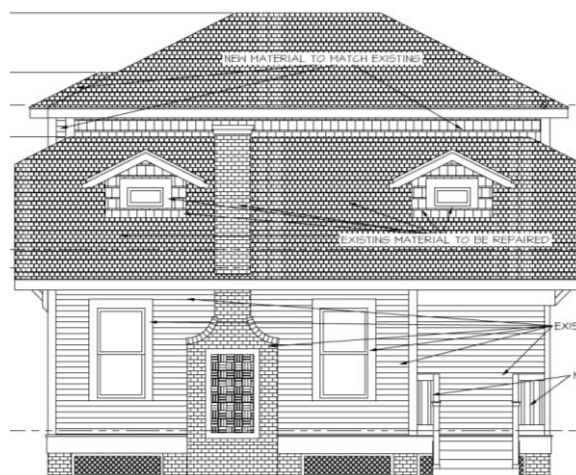
SOUTH ELEVATION – FRONT FACING WEST 12TH STREET

EXISTING

DENIED 11/20/2014

PROPOSED

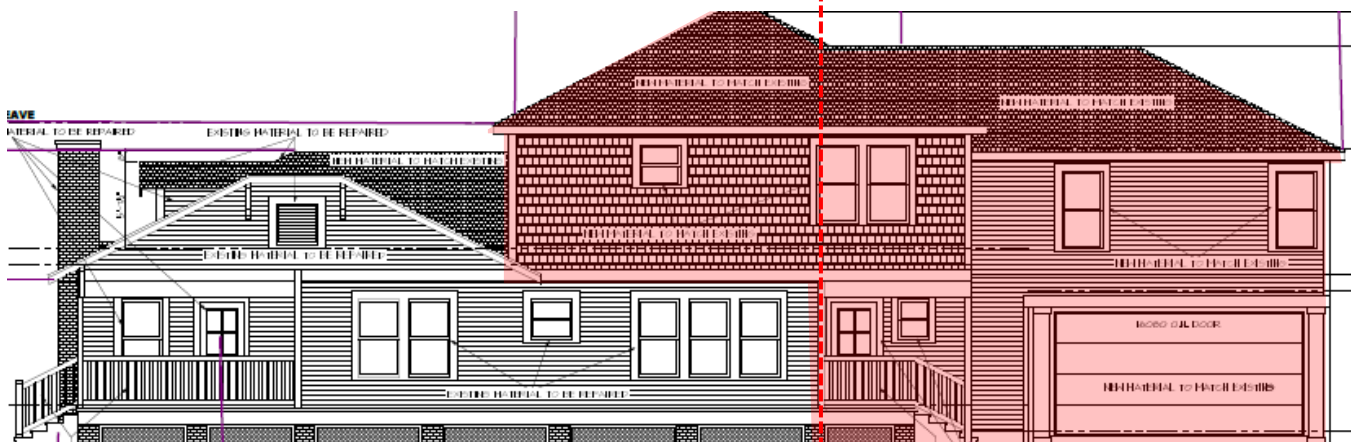
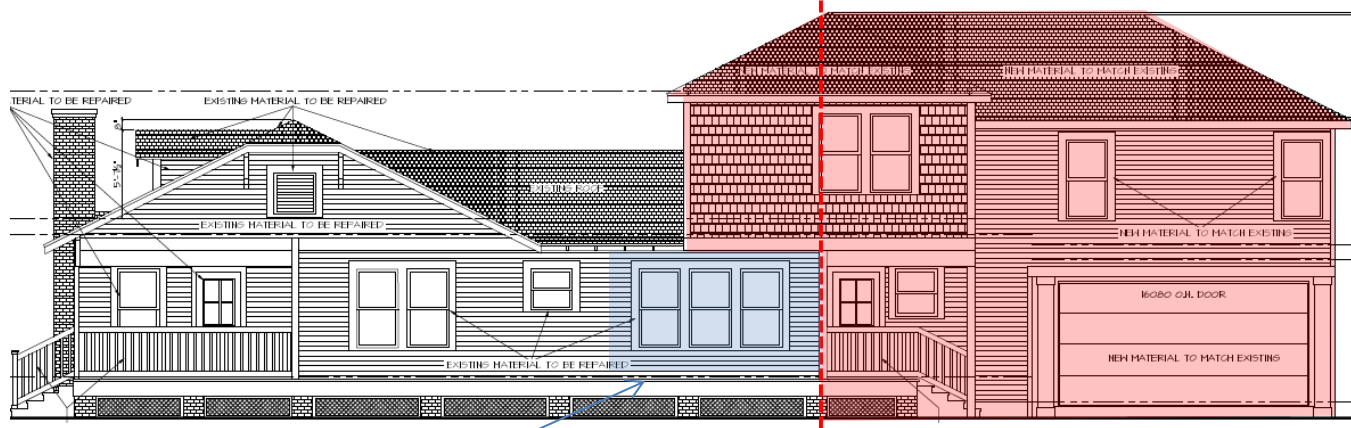
EAST SIDE ELEVATION

EXISTING

Red Dashed Line indicates the original rear wall of the existing house

DENIED 11/20/14

PROPOSED

Wall with three windows is particularly unlikely to support the added load of the second floor

Side Elevation: The addition will begin approximately 17' from the front wall, encroaching over the rear 9' of the original structure. A 10' deep non-original rear addition will also be removed in order to incorporate the new addition. The portion of the existing home behind the side gable is inset 7' from the front portion of the house. The addition will preserve this condition on the first floor but will build second story living space above the inset area. The result will be a covered side porch facing the west side property line. The second story of the addition will feature a side facing upstairs balcony directly above the first floor porch.

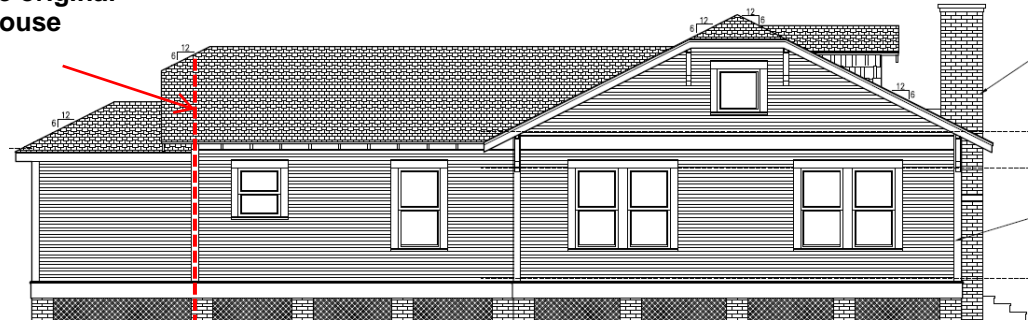
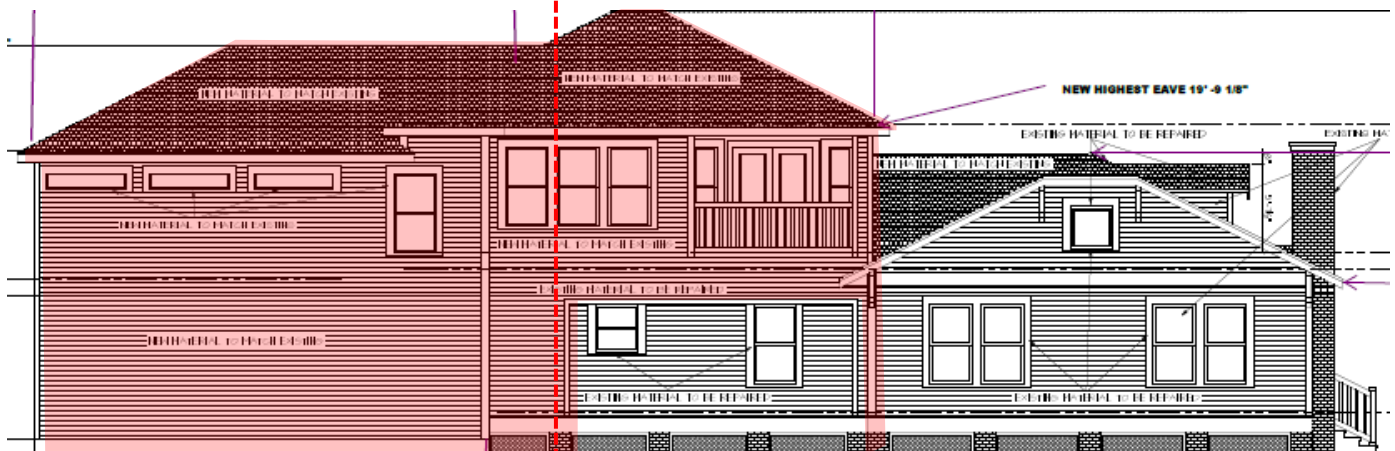
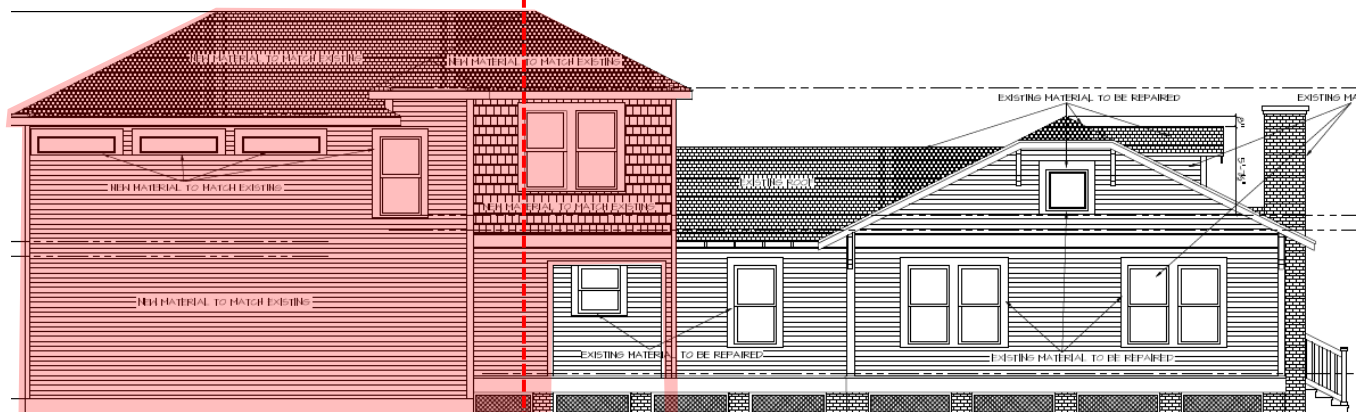
WEST SIDE ELEVATION

EXISTING

Red Dashed Line indicates the original
rear wall of the existing house

DENIED 11/20/14

PROPOSED

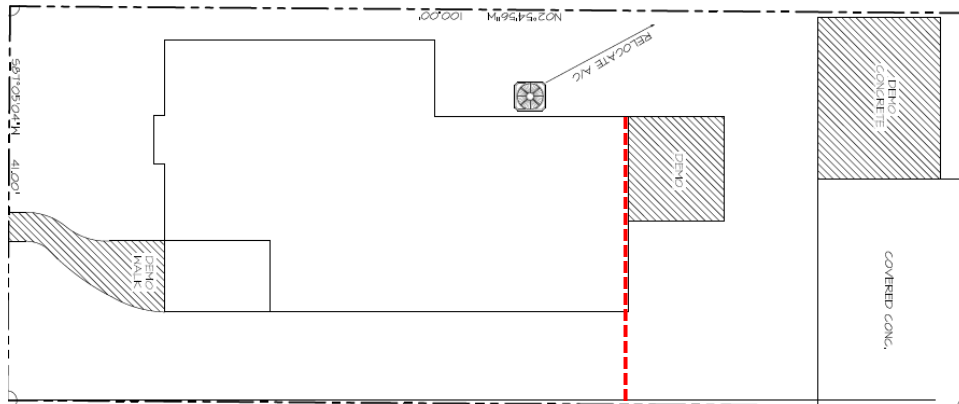
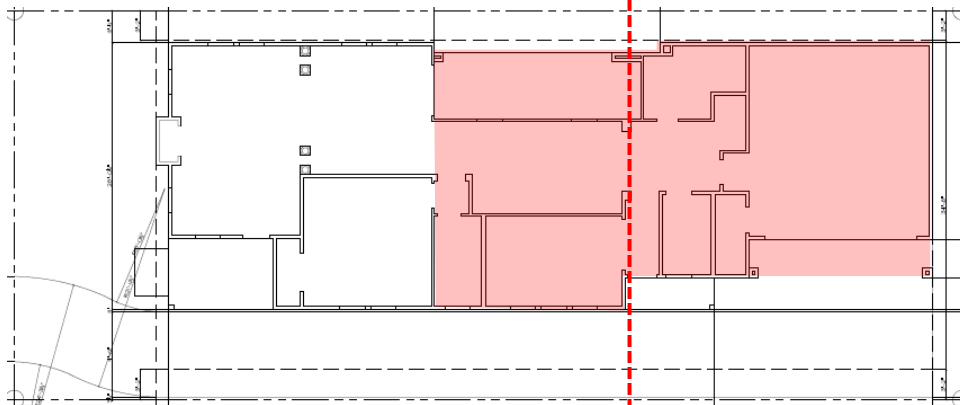
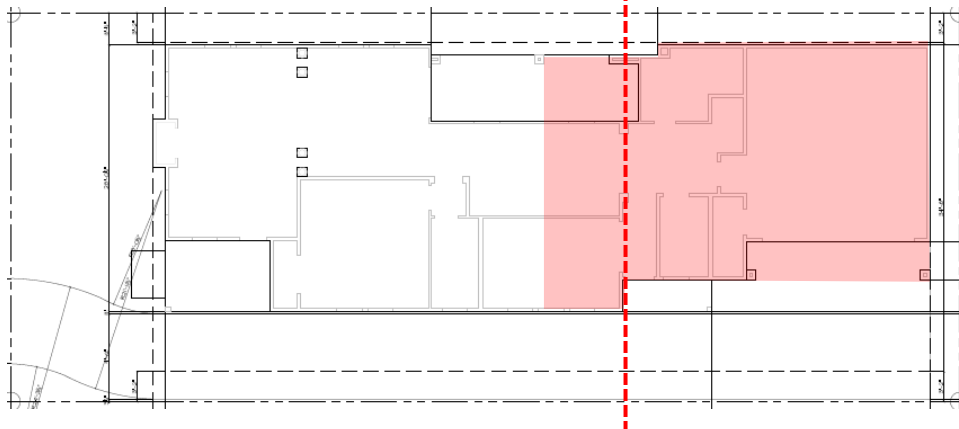
SITE PLAN

EXISTING

DENIED 11/20/14

Red Dashed Line
indicates the
original rear wall
of the existing
house

PROPOSED

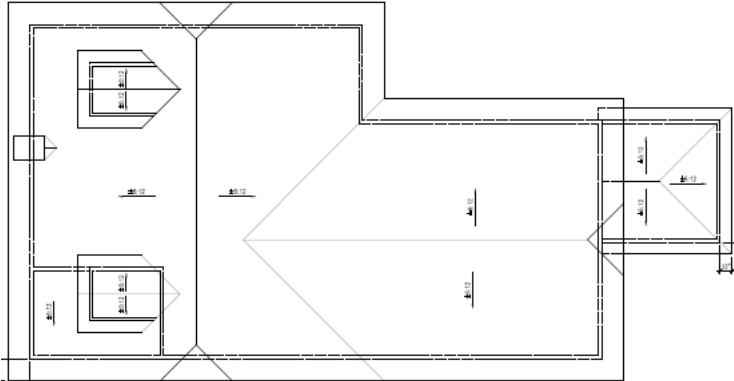
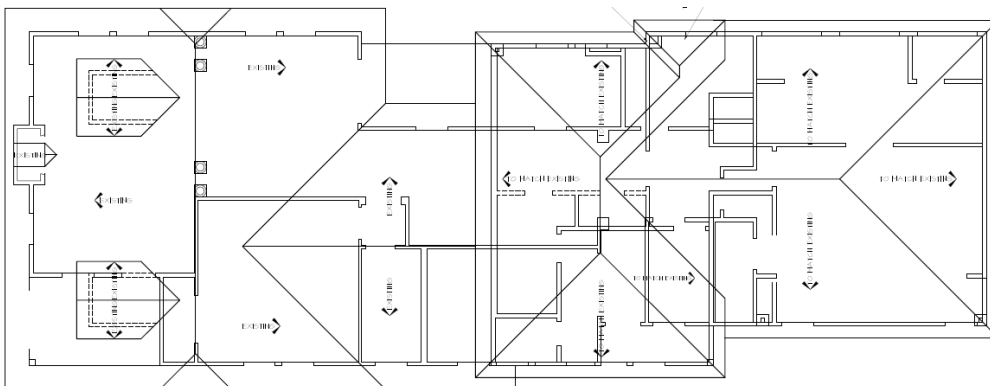
ROOF PLAN
EXISTING

DENIED 11/20/14

PROPOSED

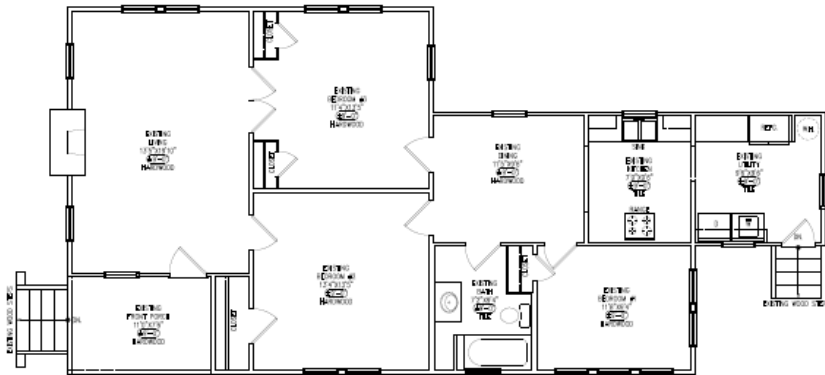
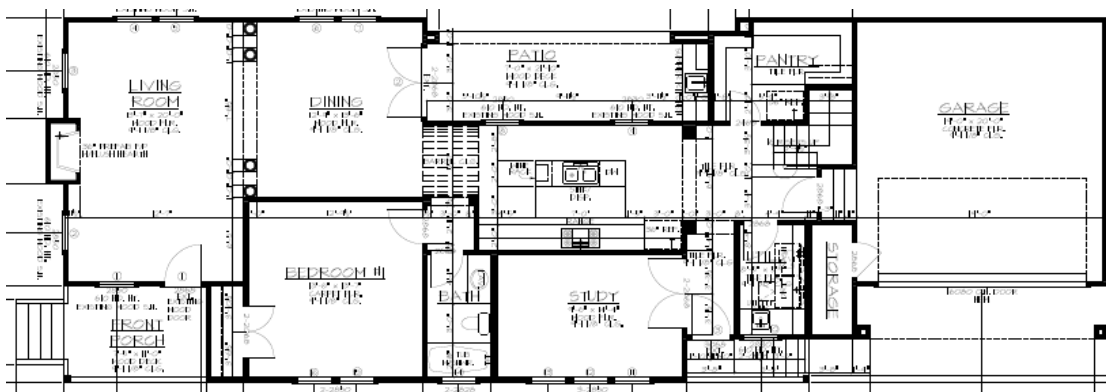
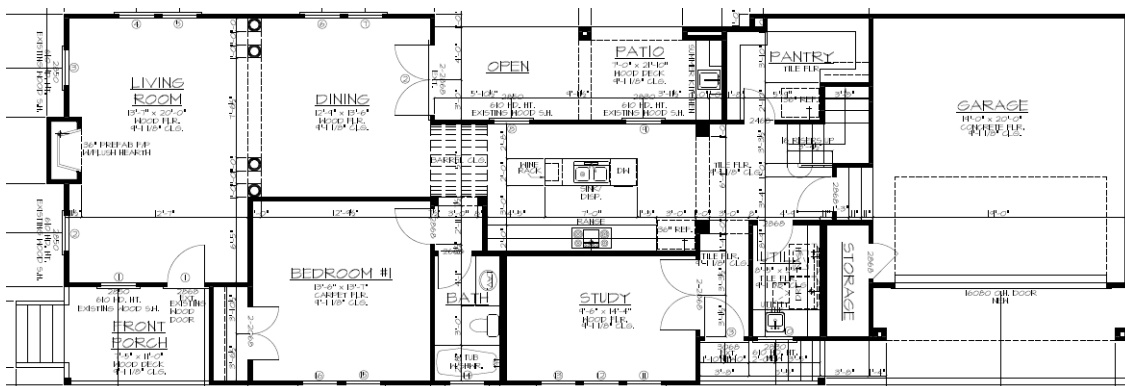
FIRST FLOOR PLAN

EXISTING

DENIED 11/20/14

PROPOSED

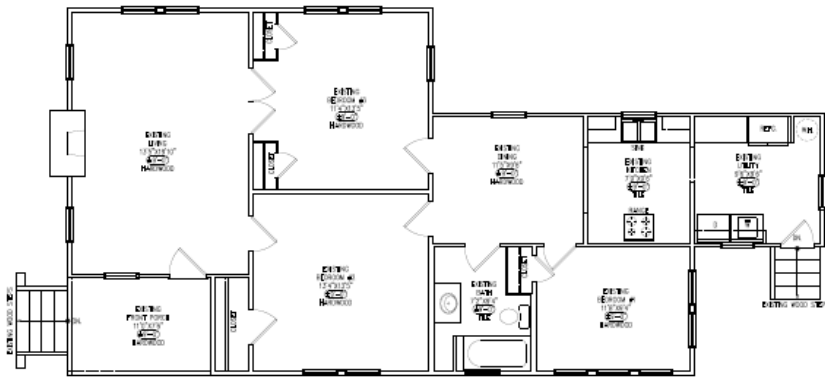
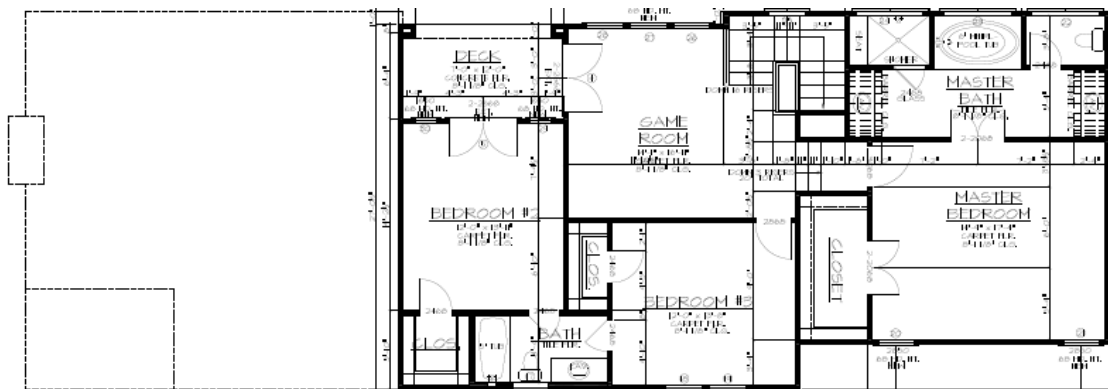
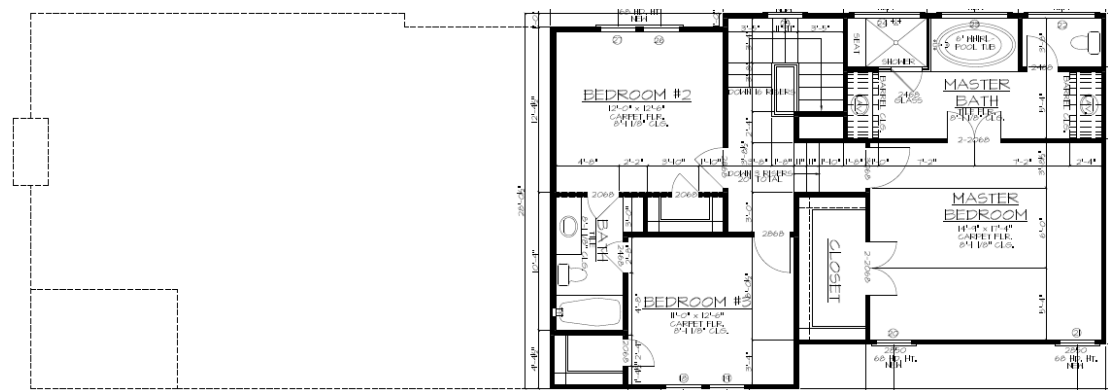
SECOND FLOOR PLAN
EXISTING FIRST FLOOR

DENIED 11/20/14

PROPOSED

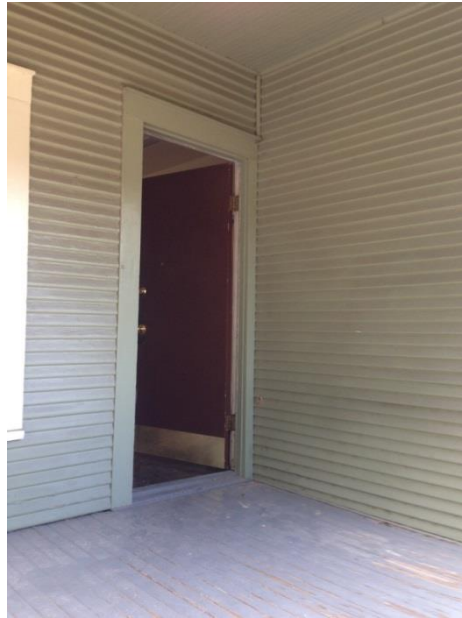
EXISTING NON-ORIGINAL FRONT DOOR

Windows/Doors: The existing house features historic 1 over 1 wood windows. These will be retained. The addition will feature interior sash mounted 1 over 1 vinyl windows. The applicant proposes to replace a non-original steel door with a wood craftsman style door within the existing opening.

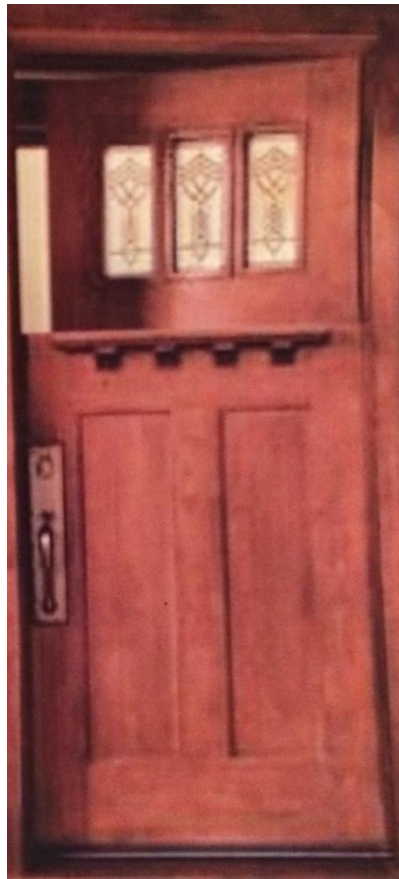
PROPOSED REPLACEMENT DOOR
